Report 1974

UNIVERSAL FOLDED PLATE (UFP) STRUCTURAL SYSTEM

Edward J. Schultze and Lloyd E. Krivanek

January 1970

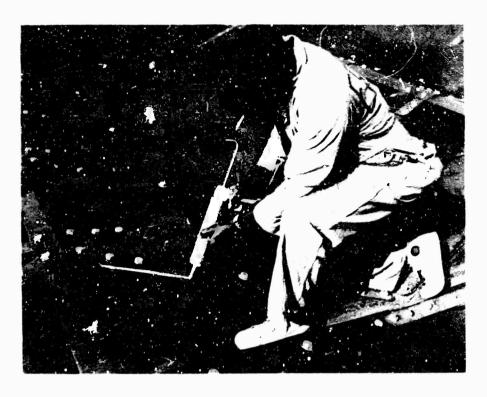
During erection of the flat-roof building, the rubber sealant gasket was stripped off of approximately one-half the UFP panels used. These panels without sealant gaskets were placed together across the building span during erection. After erection was complete, eaulking (FSN 8030-682-6422) was applied to the joints without gaskets as shown in Figs. 44 and 45.

Fig. 44. Caulking application.

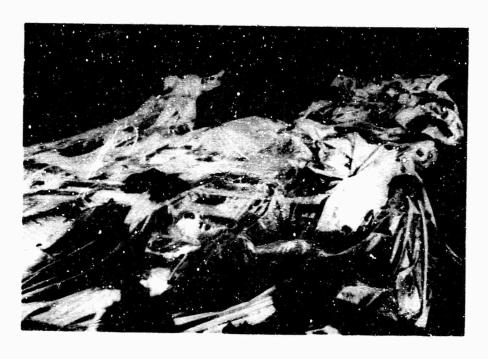
Fig. 62. Storm effects on loaded roof.

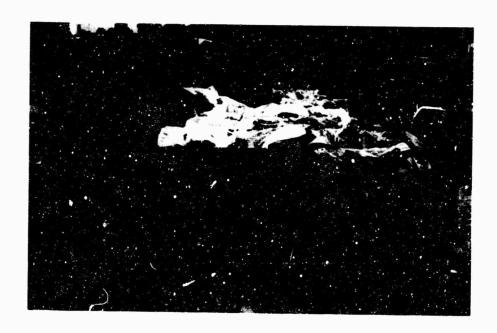
Fig. 63. Storm effects on roof cover.

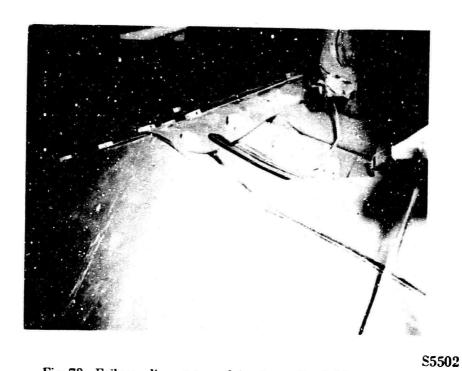
Fig. 73. Failure adjacent to nodal point on load side of beam.

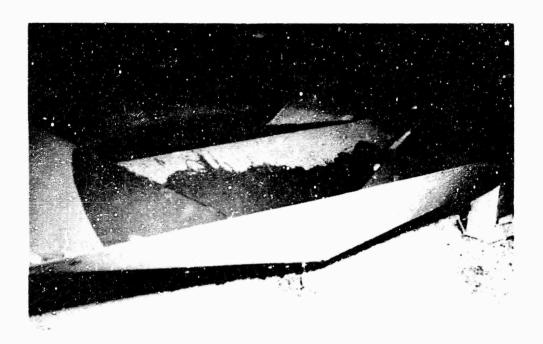
- (3) Water Test Beam. A watertightness test was performed on a test beam (Fig. 80) and on the flat-roof building. The results of this test on the flat-roof building are as shown in paragraph 7c. For the beam test, each of the two sections were filled with water to a maximum depth of 12 in. One section held water for a period of 48 hours; the other section leaked a steady stream of water. A gap existed between the mating gaskets at the nodal point where the leak existed. Leak rate was not measured.

Fig. 80. Gasket sealing eapability test.
